Bestwood Village Conservation Area Appraisal

ADOPTED MAY 2005

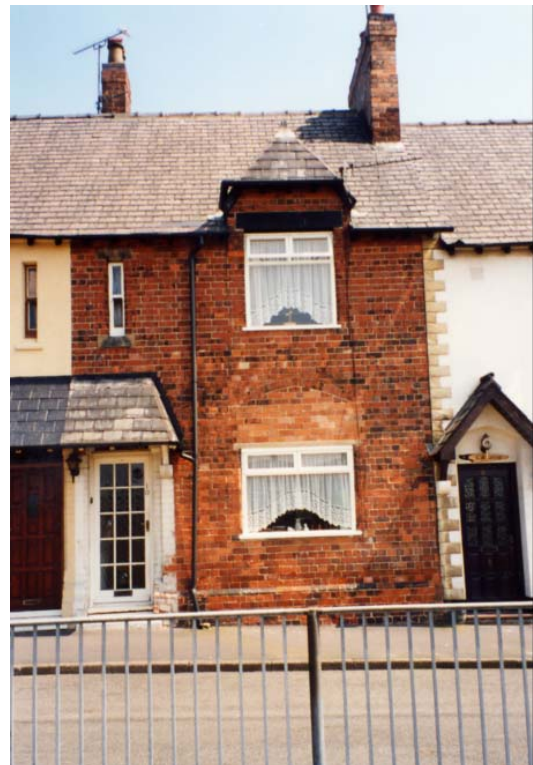
10, The Square retains some original features, such as its porch; in contrast to the neighbouring property (right), with its replacement porch and smooth render

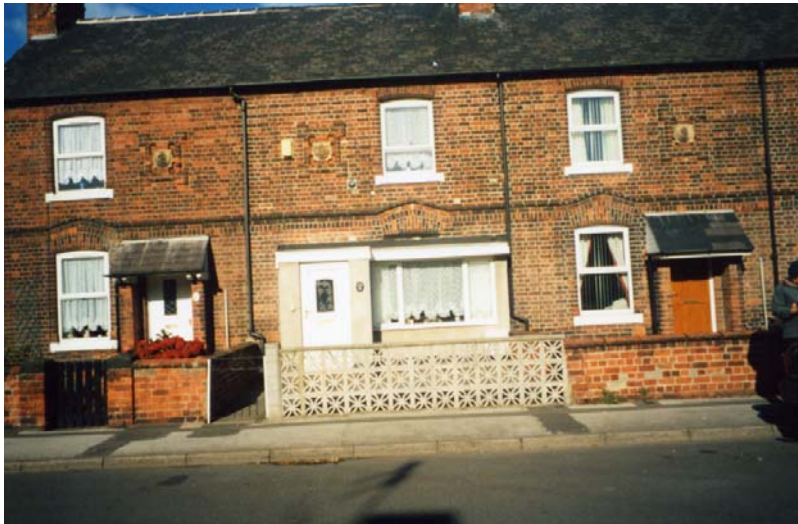
A principal argument raised by Bestwood St Albans Parish Council in 1995 to the designation of an Article 4(2) Direction (see below) was that the "Direction has arrived 20 years too late and that Architectural damage has already been done to the Village". Indeed, it is clear through the progress of this appraisal that there is some strength in this assertion. As at 2003, 7 properties along Park Road have had stone cladding additions, though from earlier photographic evidence, these works were carried out considerably prior to the 1992 Conservation Area designation. Similarly, 2 properties (16 and 46 Park Road) both have had inappropriate front and side extensions respectively that have damaged the historic uniformity of that road.

46 Park Road, showing inappropriate flat roofed front extension and replacement boundary wall, constructed during the 1980s

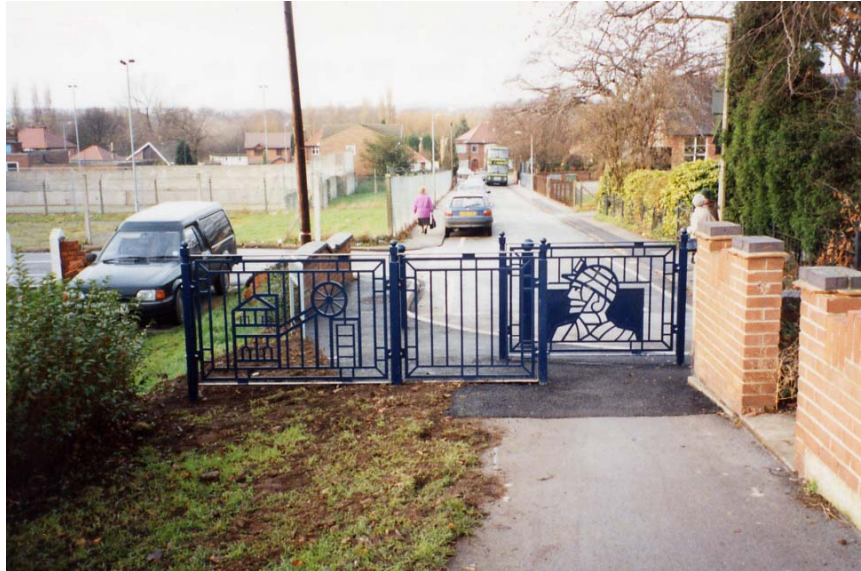
*The Mount/
School Walk
pedestrian
railings,
installed 1995*

Appropriate designs featuring a miner's head and colliery headstock were agreed and replacement barriers installed at the end of 1995, together with new bollards, raised kerbs and resurfacing, at a total cost of £663. Currently the railings remain in a good condition, but the paintwork appears to have suffered some damage over the decade since they were installed.

POLICY 4: *It is proposed that the 1995 pedestrian barriers at The Mount/ School Walk be cleaned and repainted in order to protect them for the future.*

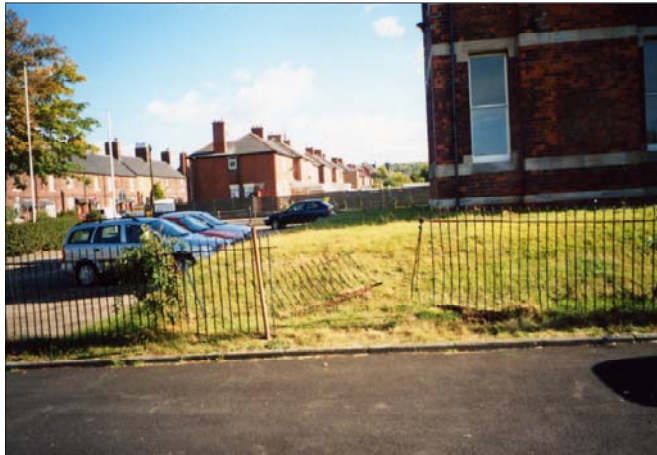
- ◆ Universally poor state of pavements;
- ◆ Continuing poor condition or inappropriate replacement of boundary railings, as at the Clock Tower (former British Coal offices), Bestwood Hotel and Miners Welfare;
- ◆ Isolated areas of poorly maintained land, eg. Miners Welfare (Church Road), Bestwood Hotel;
- ◆ Well maintained/ managed principal areas of public open space, both at The Square and Bestwood Country Park;
- ◆ Level local topography situated within a hollow near to River Leen provides considerable natural shelter, enclosed by "The Mount" and reclaimed colliery spoil heap;

Broken Railings, The Clock Tower, Park Road

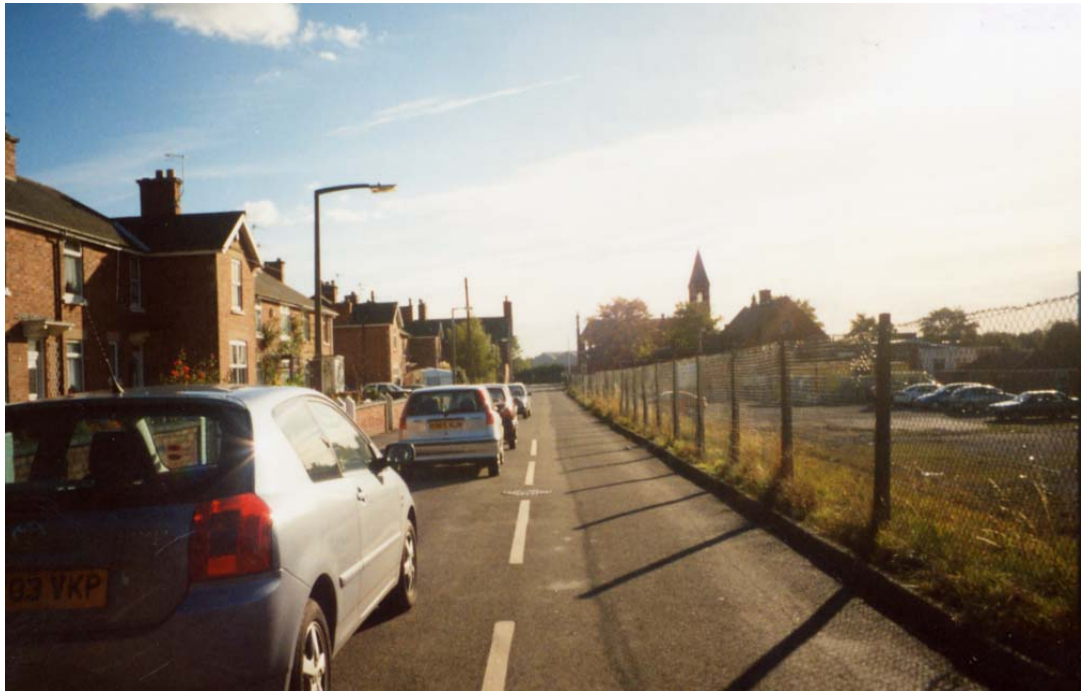
Church Road southern vista, showing dominance of the Clock Tower, Miners' Welfare and its poorly maintained car parking/ hard-standing area

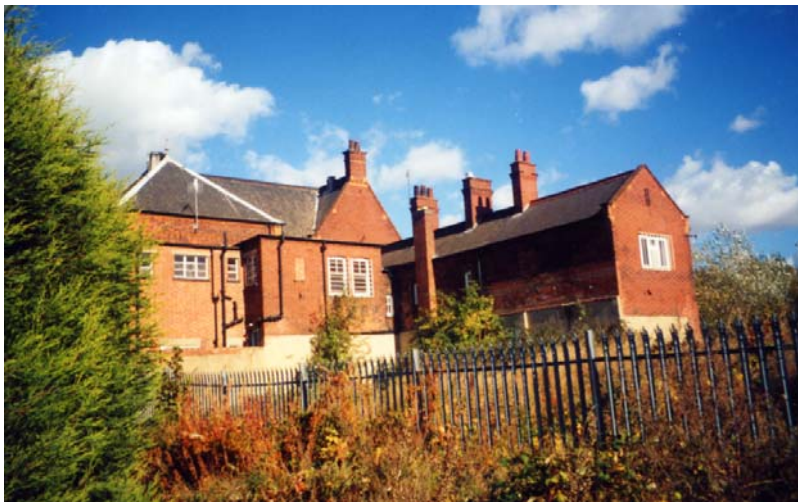
Site of former flat roofed section of Pit-head baths to the rear (south) of Bestwood Hotel. Conservation Area Enhancement schemes should significantly improve views into Bestwood Village from the Country Park

IMPLEMENTATION: Through Conservation Area Enhancement Grant; working with the Bestwood Hotel proprietors and County Council (responsible for the maintenance of the Country Park).
