**LAMBLEY VILLAGE CONSERVATION AREA
CHARACTER APPRAISAL & MANAGEMENT PLAN
NOVEMBER 2020**

Executive Summary

Conservation Area Character Appraisal

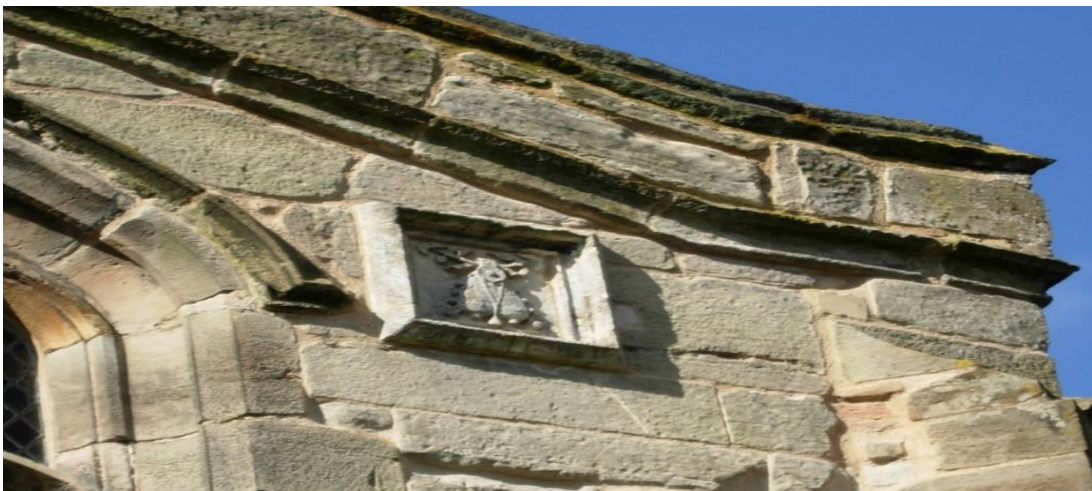
Photo 12: Holy Trinity Church eastern façade which includes the badge of Sir Ralph Cromwell in stone panels either side of the east window.

- 6.5 A new church was built in the 12th Century to replace the one recorded in the Domesday survey. Sir Ralph Cromwell who was the last of the line of the Cromwells died in 1456 and the manor and estate eventually passed to the Clifton family. Sir Ralph Cromwell made provision in his will to rebuild the church which was carried out some time after his death due to legal issues over the inheritance. The rebuilding took place probably during the 1470s as the church was re-dedicated in 1480. The Holy Trinity Church is regarded by the art historian Nikolaus Pevsner as one of the finest perpendicular churches in Nottinghamshire⁵. It is the resting place of Cromwell's parents and bears Sir Ralph Cromwell's badge of office on the eastern façade of the church.

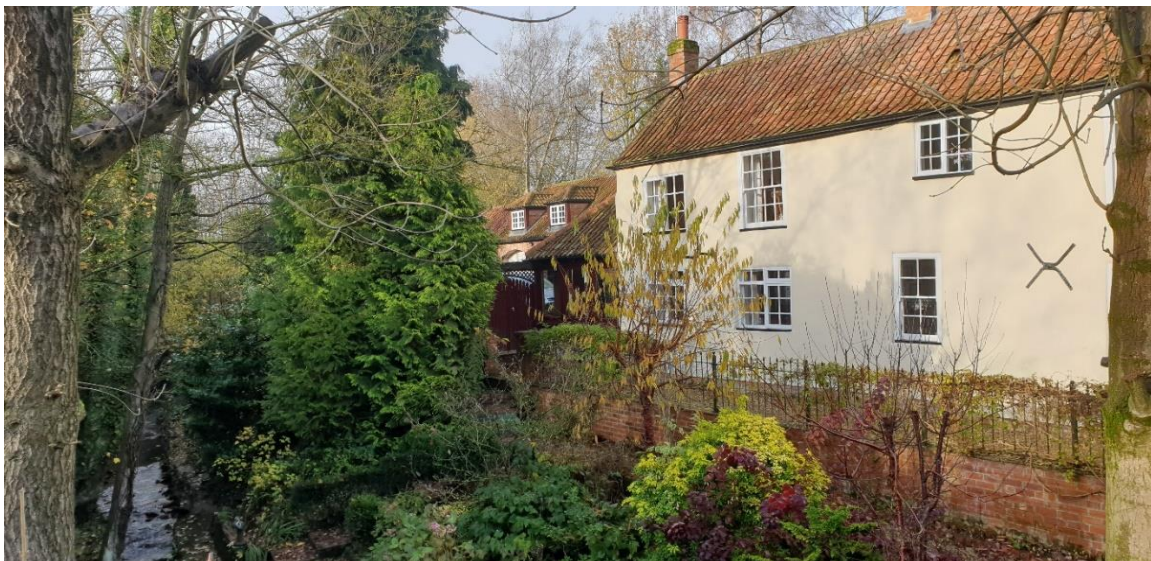
- 11.3 On the corner of Spring Lane and Catfoot Lane stands the Grade II Listed Brookside House, an attractive late 17th Century timber framed, brick and rendered house (**photo 26 below**). The garden falls away to the stream and together with the mature trees makes a pleasant scene.

Photo 26: Brookside House

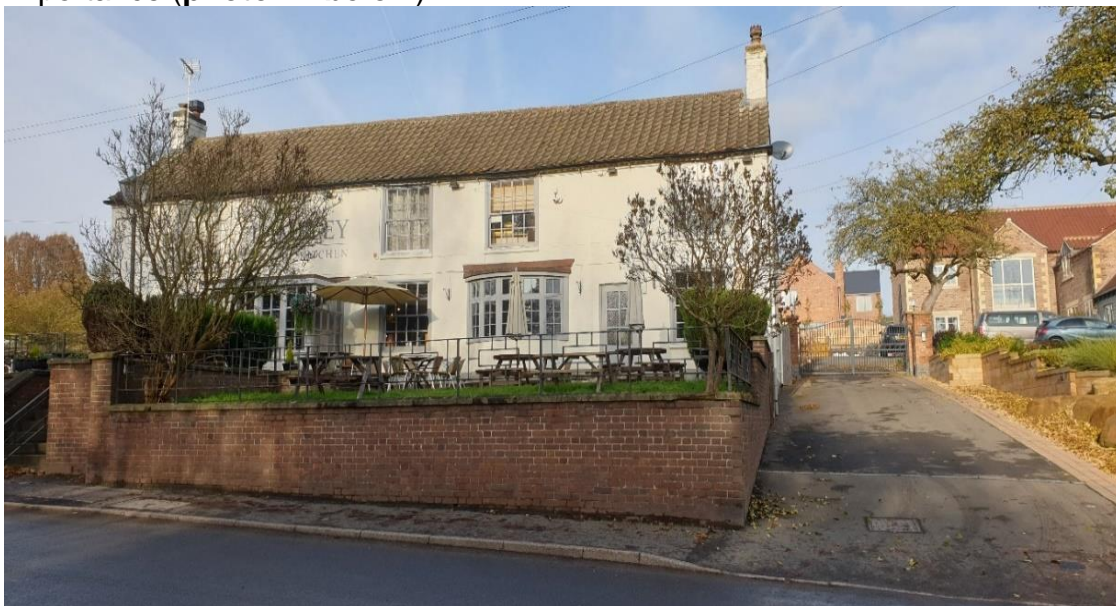
- 11.6 The Lambley Public House dominates the street scene when approaching from the west. This is a large late eighteenth century building with sixteen pane sash windows. It appears slightly separated from the rest of the village and slightly set back from the road at a higher level which gives it prominence and a sense of importance (**photo 27 below**).

Photo 27: View of The Lambley from Main Street

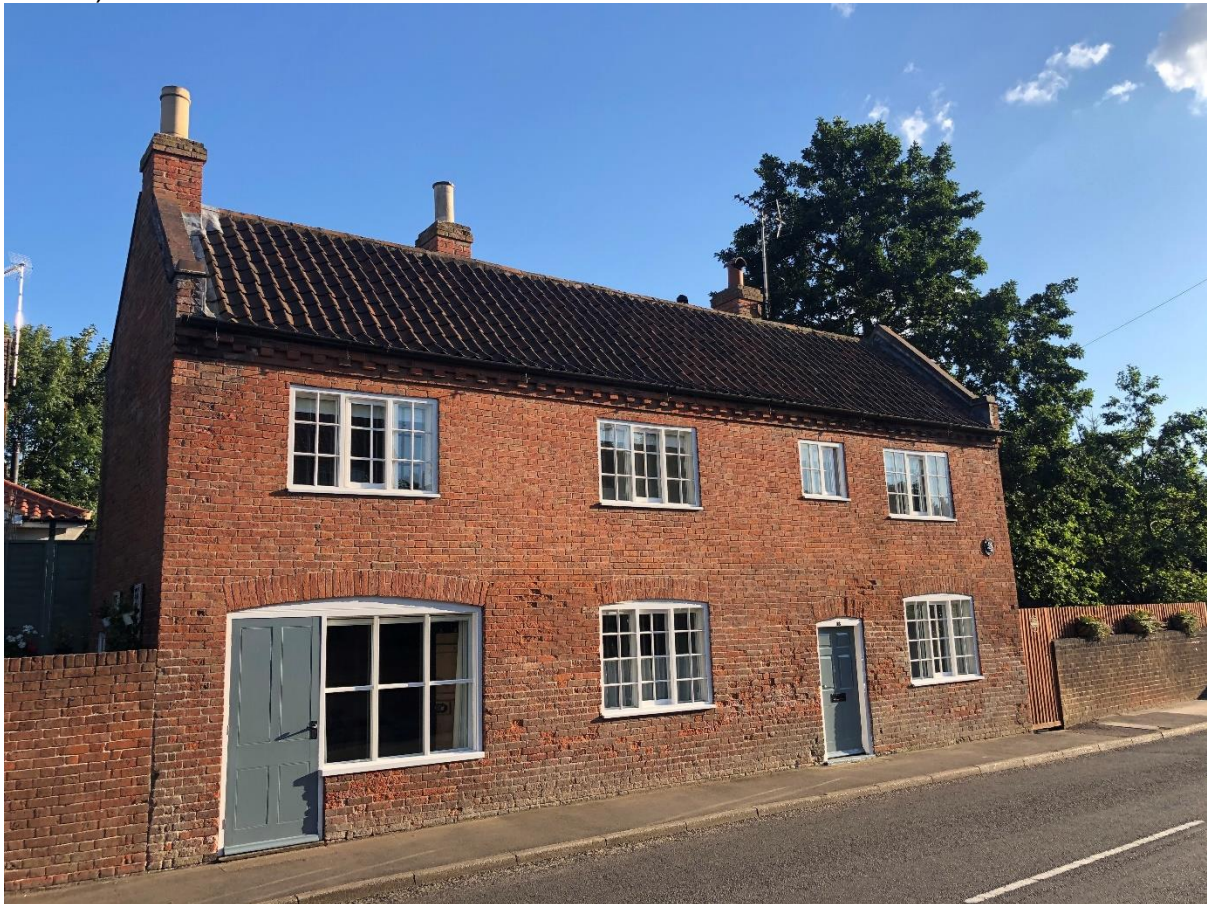
- 11.8 Number 18 Main Street has a grade II listing and is a former general store. This building has original features including Yorkshire sash windows and a raised dentilated eaves course of bricks. This is a prominent building facing and opening onto the street and an important building within the Conservation Area (**photo 28 below**).

Photo 28: No 18 Main Street

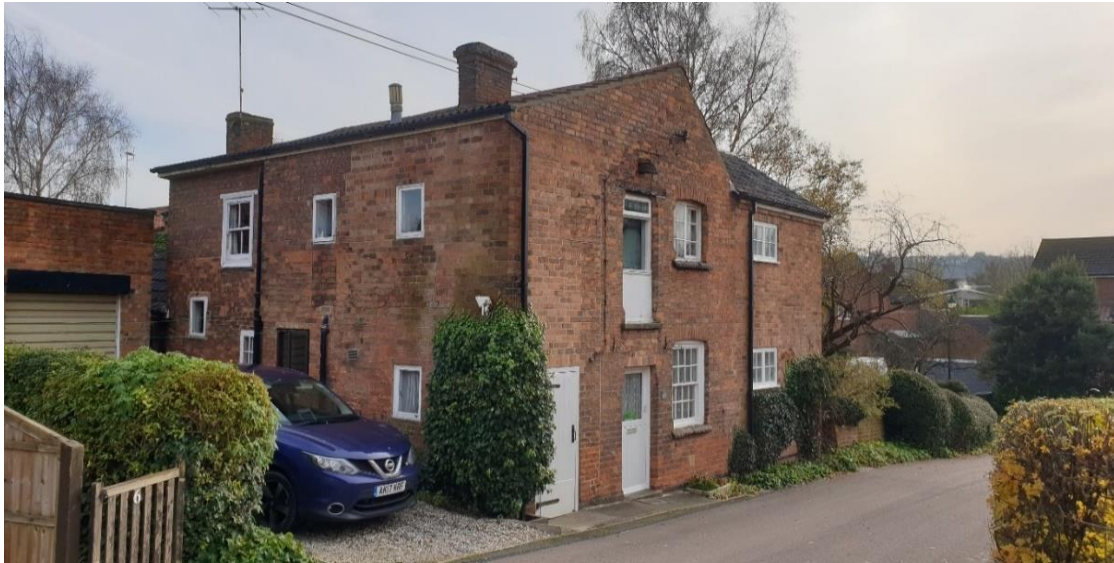
- 11.9 Almost opposite 18 Main Street on the other side of the road is 45 Main Street which retains several original features. This includes a loading hoist and loading door to the upper storey associated with its previous use as a bakery (**photo 29 below**).

Photo 29: No 45 Main Street

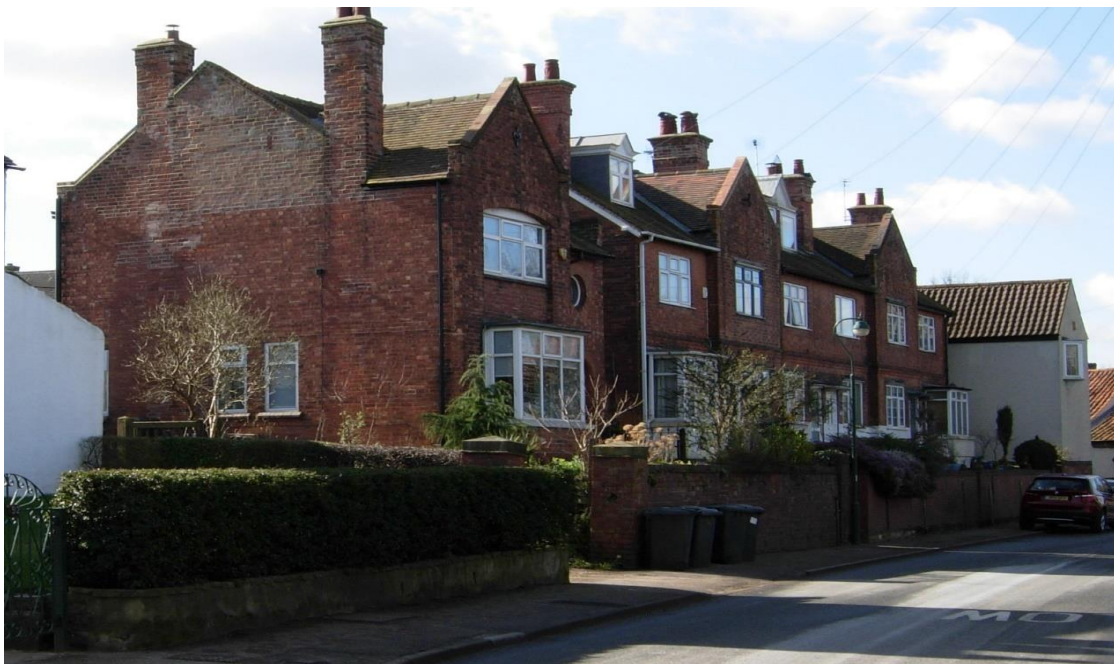
- 11.10 Numbers 32 – 46 Main Street, which forms a row of houses, and the detached 48 Main Street at the end of the row make an interesting group of Edwardian Middle Class houses, which are prominent on the curving Main Street. Though typical of their period their 'pattern-book' design and attention to detail contrasts with the simplicity of traditional building within the Conservation Area (**photo 30 below**).

Photo 30: Numbers 32 to 46 and 48 Main Street

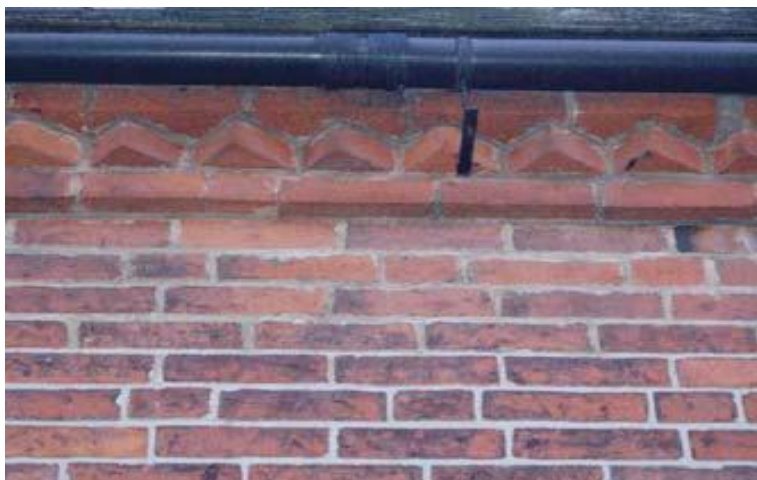
Photo 57: Irregular Flemish Bond with Dog-toothed eaves.

- 12.2 There is a range of building materials with red/orange brick being the most common material. Some buildings have been rendered. Roofs are typically covered with clay pantiles although some are in slate. There is also a range of window styles including timber vertical and horizontal (Yorkshire) sliding sash windows, framework knitters' windows and casements. Arched brick openings are common. However, a number of houses have lost their original timber windows and doors, which have been replaced by upvc that lacks the scale and proportion of the originals and detract from the appearance of the relevant buildings and Conservation Area.

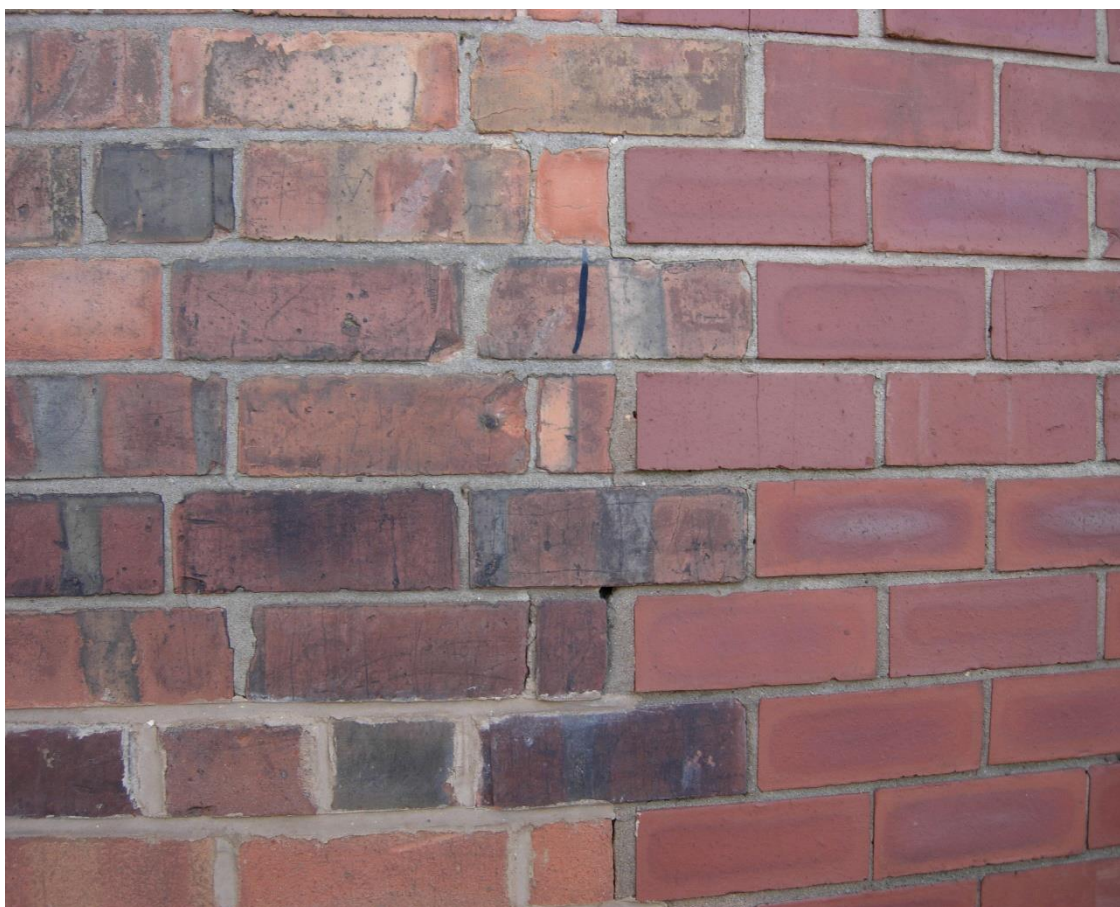
Photo 61: Repairs to brickwork do not match the older type and unsympathetic cement rich pointing that does not match the original mortar type and finish on older structures should be avoided.

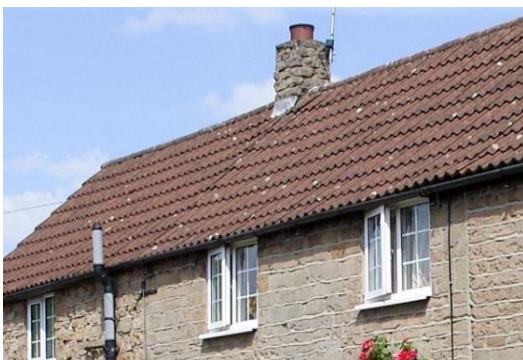
Photo – casement windows

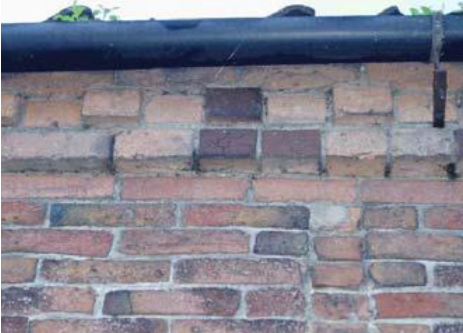
Dentilated eaves – usually found at eaves level or used as a string course. Alternate brick headers project from the wall as below.

Photo dentilated eaves

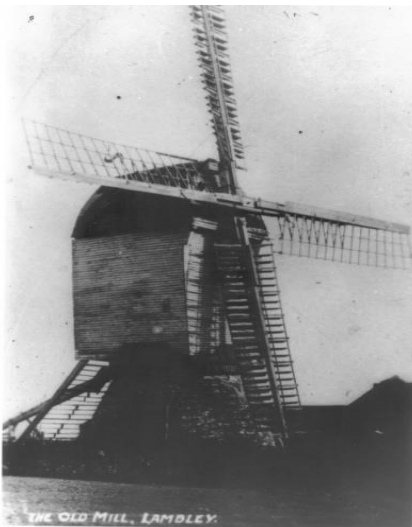
Post Mill - The post mill is the earliest type of European windmill introduced to England soon after the Norman Conquest. In these windmills a large central vertical post supported the whole machinery and storage. The whole body could then turn around the post to bring the sails into the wind. The vertical post would sit on a trestle – a wooden substructure supporting the post. In the case of Round Hill, Lambley the mound is the visible remains of the foundations resulting in an earthwork.

Photo of a post mill, Old Mill Lambley

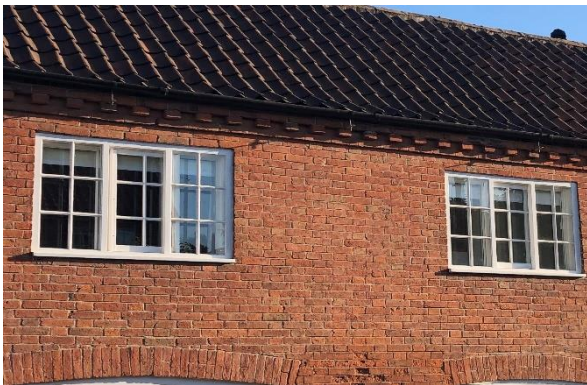
Photo of 18 Main Street with horizontal Yorkshire sliding sash windows.
